Combined Health, Safety and Fire Risk Assessment.

Reference Number:	FRA No. AGO/BML
Address of Premises:	Comfrey House, 42 Seacole Crescent, Swindon, SN1 4GN
Responsible person (e.g. employer) or person having control of the premises:	Comfrey House RTM Company Ltd Duty Holder: Block Management Ltd
Person (s) consulted:	No occupier or other relevant person available to consult
Assessor:	Rob Cockburn
Quality Control Auditor (If Required):	John Godfrey, GIFireE.
Date of assessment:	4 th March 2024
Date of previous assessment:	N/K
Suggested dates for review: (1)	March 2026

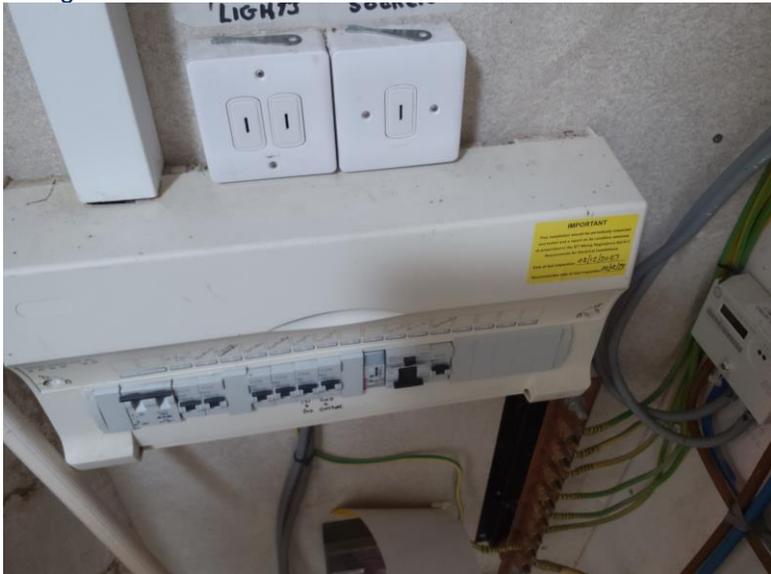
7.3	Comments and Hazards Observed:	
	<p>According to the sticker attached to the consumer unit, the fixed electrical installation was last inspected and tested in December 2023.</p> <p>All fixed electrical installations supplying the communal areas of a residential property should be inspected and tested by a competent person every five years in accordance with Electricity at Work Regulations / IEE Wiring Regulations Eighteenth Edition 2019 / British Standard 7671: 2018 and a written Electrical Condition Report (EICR) obtained.</p> <p>It is recommended that the RP create a management action to ensure the electrical installation is retested on a five yearly rolling basis.</p> <p>There were no trailing leads or adapters identified within the common areas at the time of this assessment.</p>

02	<p>According to the sticker attached to the consumer unit, the fixed electrical installation was last inspected and tested in December 2023.</p> <p>All fixed electrical installations supplying the communal areas of a residential property should be inspected and tested by a competent person every five years in accordance with Electricity at Work Regulations / IEE Wiring Regulations Eighteenth Edition 2019 / British Standard 7671: 2018 and a written Electrical Condition Report (EICR) obtained.</p> <p>It is recommended that the RP create a management action to ensure the electrical installation is retested on a five yearly rolling basis.</p>

MED	Client	<p>Ongoing Action</p> <p>Managing agent maintain central record of EICR due dates</p>

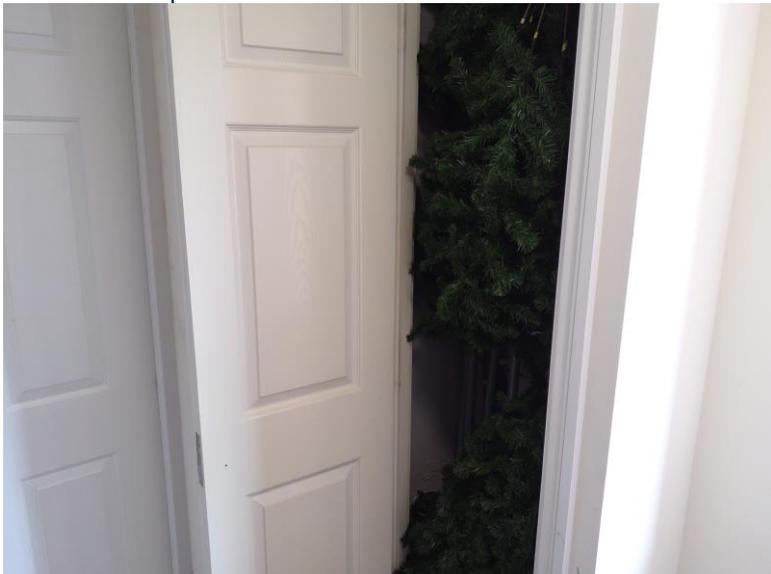
• Is upholstered furniture in good condition and foam infill is not exposed?	N/A
14.1	Comments and hazards observed:	
	<p>Housekeeping was found to be of a poor standard at the time of this assessment with the riser cupboards congested with residents' possessions and storage. It is recommended that the client arrange for the communal areas to be cleared as a priority and all residents reminded of the importance of maintaining sterile riser cupboards.</p> <p>Waste is well managed.</p>

03	<p>The surrounding areas of the premises including hard and soft landscaping and car parking areas were found to be in good visual condition with paved and Tarmacked surfaces reasonably level and free from major indentations or potholes. Landscaping & external grounds maintenance is of an acceptable standard. These areas should be periodically inspected by the RP and the results of each inspection recorded.</p>	LOW	Client	<p>Ongoing Action</p> <p>Managing agent inspect communal areas</p>
04	<p>Housekeeping was found to be of a poor standard at the time of this assessment with the riser cupboards congested with residents' possessions and storage. It is recommended that the client arrange for the communal areas to be cleared as a priority and all residents reminded of the importance of maintaining sterile riser cupboards.</p>

MED	Client	<p>Ongoing Action</p> <p>Residents are reminded to keep communal areas sterile, notices are posted on the communal notice board.</p>

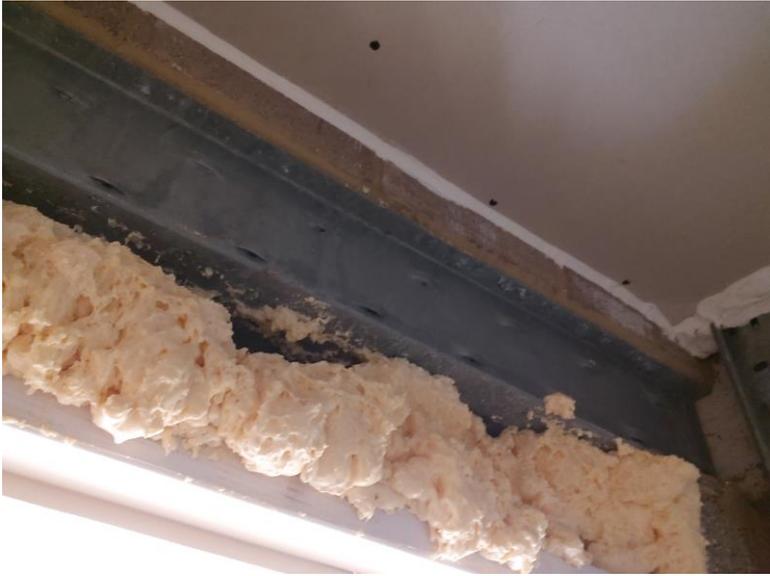
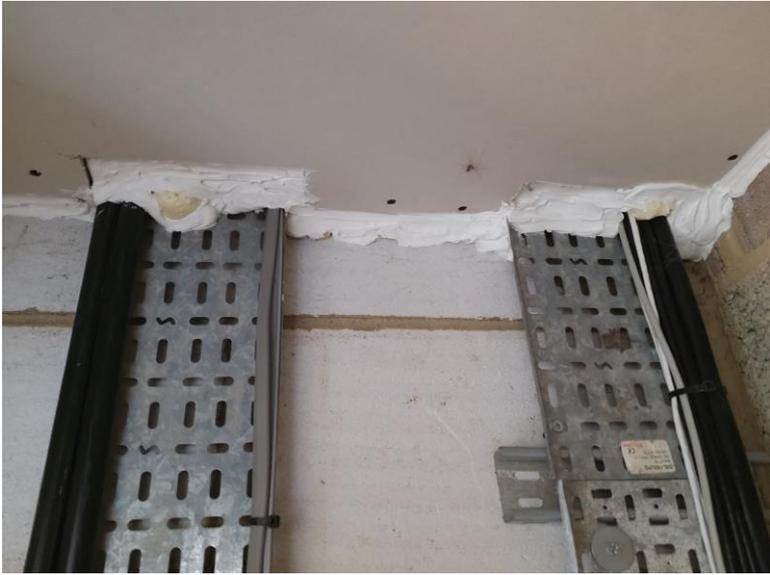
19.3	Comments and deficiencies observed:	
	<p>It was noted during this fire risk assessment that multiple riser cupboards and the electrical intake cupboard had an excessive use of sealants whether foam sealant or intumescent sealant. These compounds may not have the integrity to fire stop large breaches in the compartmentation they only have the integrity to seal the edges of other compounds. It is therefore recommended that the RP instructs a suitably qualified and competent contractor to install a fire-resistant compound capable of providing a minimum of 30 minutes fire resistance for large breaches. This work should be certified upon completion.</p> <p>It was noted during this fire risk assessment that the fire stopping within the electrical intake cupboard and the second-floor electrical riser was poor. It is recommended that the RP instructs a suitably qualified and competent contractor to repair the breaches with a suitable compound capable of providing a minimum of 30 minutes fire resistance. This work should be certified upon completion.</p> <p>It is essential that each flat entrance door is a suitable fire door, providing a minimum of thirty minutes fire resistance, hung on three grade 13 hinges and having a functioning self-closing device fitted that positively closes the door on the latch, together with smoke and intumescent seals. It is recommended therefore that the RP instruct a competent person to inspect the flat entrance doors and provide advice on suitability. Any shortcomings identified by this inspection should be addressed as a priority by upgrading or replacing the door.</p> <p>Flat entrance doors, the seals and the self-closing devices should then be subjected to a periodic inspection and maintenance schedule.</p>

07	<p>It was noted during this fire risk assessment that multiple riser cupboards and the electrical intake cupboard had an excessive use of sealants whether foam sealant or intumescent sealant. These compounds may not have the integrity to fire stop large breaches in the compartmentation they only have the integrity to seal the edges of other compounds. It is therefore recommended that the RP instructs a suitably qualified and competent contractor to install a fire-resistant compound capable of providing a minimum of 30 minutes fire resistance for large breaches. This work should be certified upon completion.</p>

MED	Client	Action Completed
----	---	-----	--------	------------------

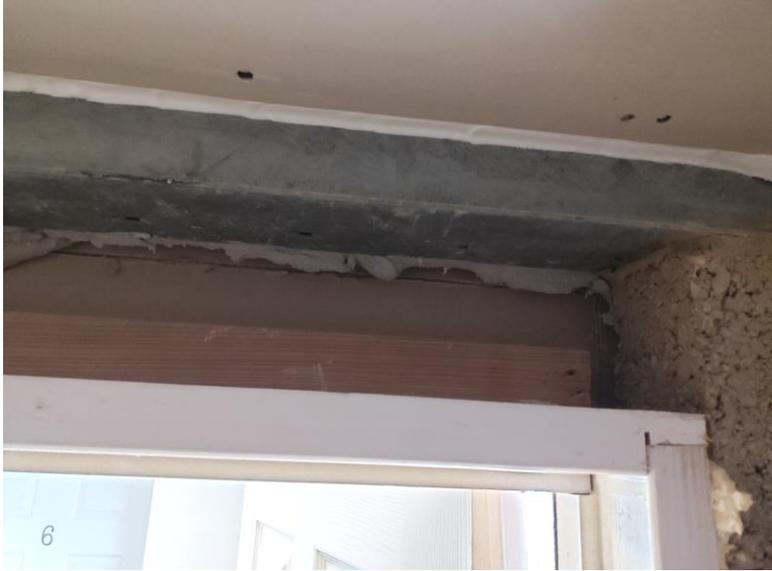
08	<p>It was noted during this fire risk assessment that the fire stopping within the electrical intake cupboard and the second-floor electrical riser was poor. It is recommended that the RP instructs a suitably qualified and competent contractor to repair the breaches with a suitable compound capable of providing a minimum of 30 minutes fire resistance. This work should be certified upon completion.</p>

MED	Client	Action Completed
09	<p>It is essential that each flat entrance door is a suitable fire door, providing a minimum of thirty minutes fire resistance, hung on three grade 13 hinges and having a functioning self-closing device fitted that positively closes the door on the latch, together with smoke and intumescent seals. It is recommended therefore that the RP instruct a competent person to inspect the flat entrance doors and provide advice on suitability. Any shortcomings identified by this inspection should be addressed as a priority by upgrading or replacing the door. Flat entrance doors, the seals and the self-closing devices should then be subjected to a periodic inspection and maintenance schedule.</p>	MED	Client	<p>Action Required</p> <p>Inspection scheduled for first half 2025.</p>
